WATER QUALITY SURVEY SUMMARY  
FOR THE  
SAN JUAN RIVER WATERSHED  
2002

Surface Water Quality Bureau  
**New Mexico Environment Department**

October 2008

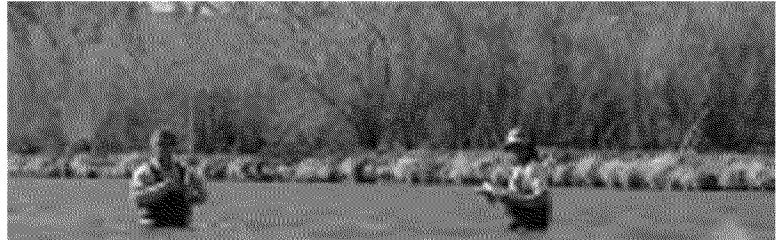
**Figure 3: Discharge measurement in the San Juan River near Soaring Eagle Lodge.**

- San Juan River at Soaring Eagle Lodge: This is not an SWQB sampling station. We are supporting volunteer monitoring here, including installing a staff gage and modeling a rating table.

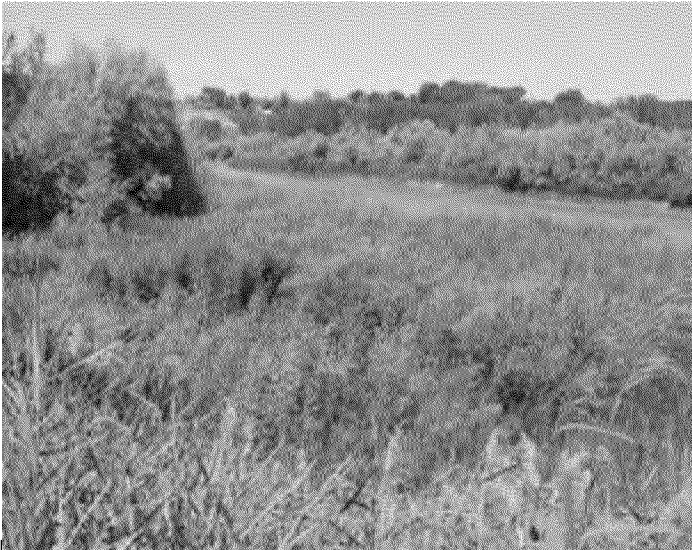
**Figure 5: Lush riparian vegetation along a reach of the San Juan River, about 4 miles downstream from Bloomfield, August 12, 2002.**

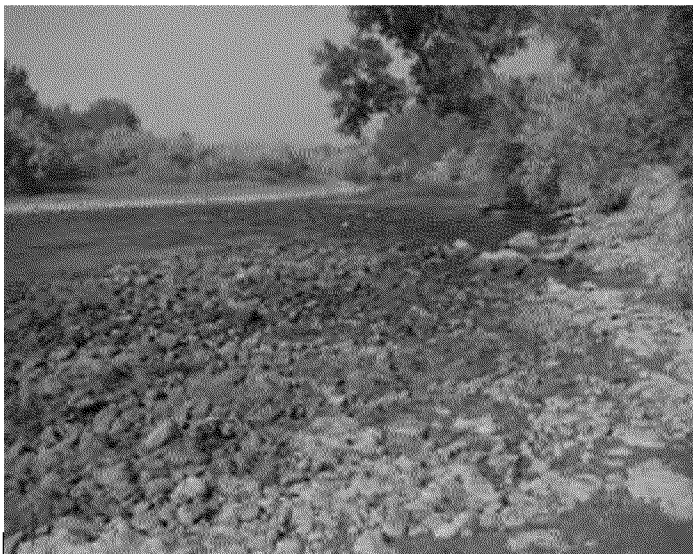
**Figure 7: Algae on bar of Animas River, October 24, 2002.**

- Excessive algal growth, as documented in photographs and field notes.
- Thick black sediments with a sulfurous odor, indicating widespread and significant formation of anaerobic, reducing conditions in the hyporheic zone.
- Sediments that yielded ammonia in concentrations that were acutely lethal to fish (see discussion in Ambient Toxicity, above). This ammonia was not observed in repeat samples collected just after a scour event, during which the anaerobic sediments were washed away.
- Elevated fecal coliforms in the Animas River, as discussed under Bacteriological Investigations, above.

Animas River (San Juan River to Estes Arroyo) – The potential for excessive nutrients in the Animas was noted through visual observation during the 2002 study. To address this concern, a workgroup was formed comprised of state and tribal environmental specialists, as well as concerned citizens. A nutrient survey was performed on 8/25/03 at the site approximately one mile above the San Juan River at Boyd Park. Total nitrogen values were above the ecoregion criteria of 0.42 mg/L in >15% of the samples, the percent dissolved oxygen saturation was greater than 120%, and the ash free dry mass of algal sampling was greater than 5 mg/cm<sup>2</sup>. A nutrient survey was also performed on 8/25/03 at the Flora Vista site. The chlorophyll a concentration was greater than 10 ug/cm<sup>2</sup>, the percent dissolved oxygen saturation was greater than 120%, and the ash free dry mass of algal sampling was greater than 5 mg/cm<sup>2</sup>. Since three or more indicators were present at both sites, nutrients will be added as a cause of non-support.

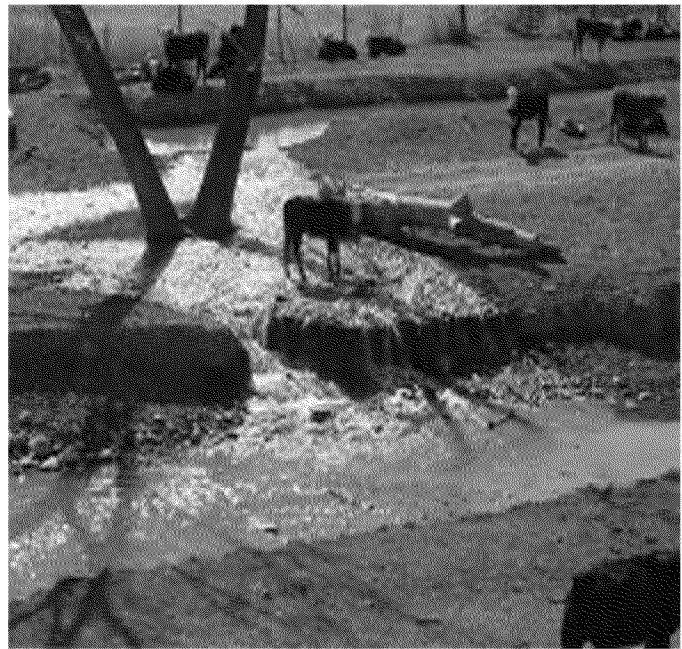
**Figure 10: La Plata River, receiving overflow from an irrigation ditch within a feedlot, April 16, 2002.**

The lower reach also has no nutrient impairment, but it demonstrates non-support due to fecal coliforms, dissolved oxygen, and sedimentation/siltation. The SWQB believes that the lower reach may be misclassified as marginal coldwater aquatic life. The La Plata River had very low flows during 2002, going completely dry at the La Plata station for about three months.
